Kenney Ridge Community:
Recommendations for Achieving an Exemplary Upper Piedmont Forested Habitat

Prepared For: Kenney Ridge Community Association

Prepared By: Samantha West, Lily Niolon-Kachur, and Gavin Beverage

Warnell School of Forestry and Natural Resources

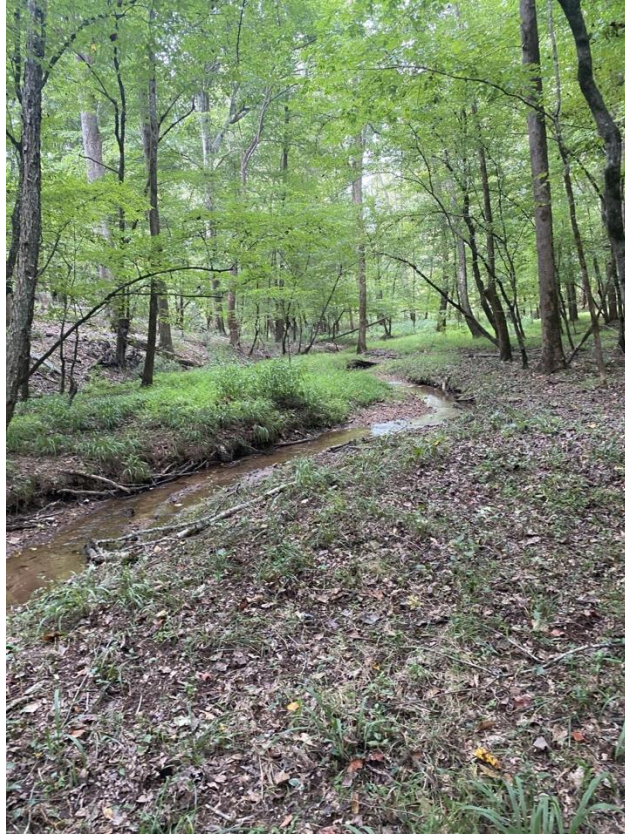
This property is located on the northwest side of Athens, Georgia along the Oconee River. The varied topography from upland to floodplain provides habitat for many species to flourish. Through the upland, Oaks and Hickories are quite prevalent, filled in by some southern pine species. The understory is largely open with a few small trees growing in the area due to limited sunlight breaching the canopy. Despite not having many understory species, some vines such as greenbrier and muscadine are quite prevalent. Two winding streams flow down the property, bringing a great blend of habitat that increases biodiversity. The streams are spring fed with clear water, eventually merging into a single channel that continues to flow down to the floodplain and into the Oconee River. Both streams express many different mesohabitats just along the streams (mesohabitats are pools, riffles, or varying substrates in a creek). From leaf litter, silty bottom, or rocky bottom there is a healthy blend of locations for wildlife to make home. The floodplain is rich with vegetation. Floodplain trees line the river and stream, canebrakes of River Cane and native grasses fill the rest of the area. Invasive plant species are present in the floodplain of the Oconee River and up the riparian corridor of the streams. Japanese Stiltgrass (*Microstegium vimineum*) and Chinese Privet (*Ligustrum sinense*) make up most of the invasive vegetation on the property.

The Kenney Ridge Property was historically cotton farmland. Previous farming practices led to disturbances on the forest floor. Large drainage ditches can be found along the property, which is likely to have caused some erosion issues through the years.

Figure 2. A photo of the Kenney Ridge stream near the floodplain.

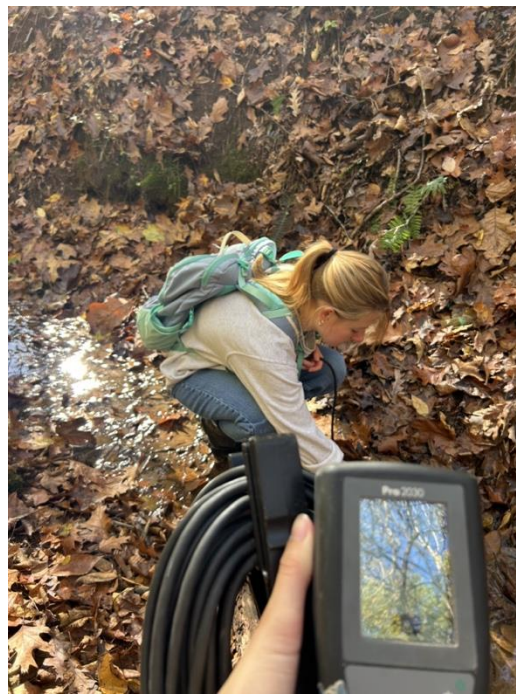
We collected water samples in plastic bottles at each of the macroinvertebrate sampling locations before we disturbed the stream. We placed the samples on ice to preserve the water properties. Once collected, the samples were taken back to the lab to be tested. We performed tests including pH, turbidity, and nitrate levels. Additionally, we took a YSI meter to the stream to take measures of temperature, dissolved oxygen, and conductivity. The stream water levels were relatively low, which made sample collection challenging. We averaged the measurements for each test from all three streams in order to get an overall estimate.

Figure 3. Samantha collecting water quality data using the YSI meter.

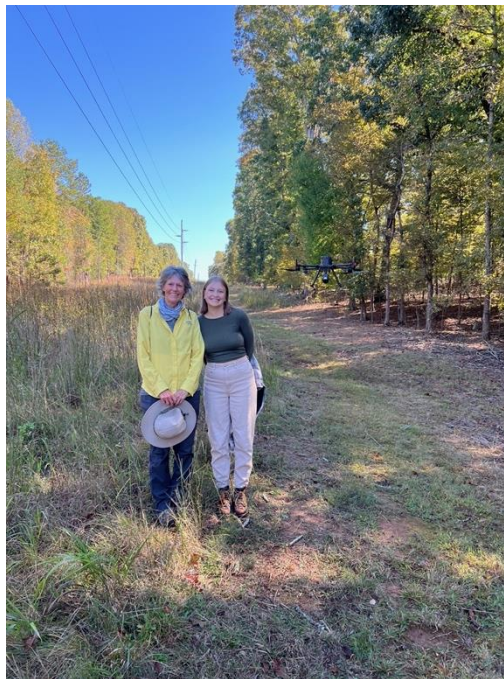
To observe the canopy cover and riparian cover around the stream, we collected lidar drone footage. We used a DJI Matrice 300 model drone with a Zenmuse L1 lidar sensor to complete the drone footage. Dr. Tripp Lowe assisted in performing the drone flight on the property. We stationed the base for the flight along the power line right of way on the property. This location is a high point and relatively open allowing us to maintain sight of the drone at all times. We were only able to obtain footage from two sections of the stream. This included the smaller stream leg as well as part of the stream near the floodplain.

Figure 4. Nancy Stangle and Lily with the drone used to take lidar footage.

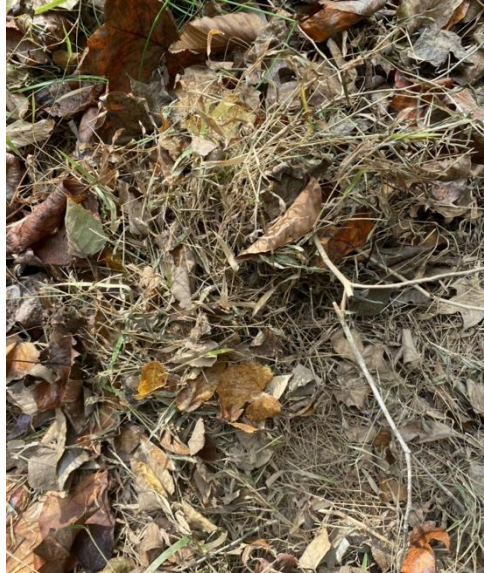
Figure 14. A photo showing a small portion of *Microstegium* that can be controlled by manual pulling.

Our recommendations for *Microstegium* control will vary based on the size of the colonization area. In areas designated as smaller portions (purple points on Figure 13), we recommend the continued practice of community workdays using manual control by pulling the grass. Pulling grass before it seeds is ideal to prevent unwittingly dispersing seeds and ensure that spread of *Microstegium* does not continue. We also recommend pulling the *Microstegium* during early to mid-summer before it begins to flower. The flowering range for *Microstegium* is mid-September to late October (Neal and Judge 2023).

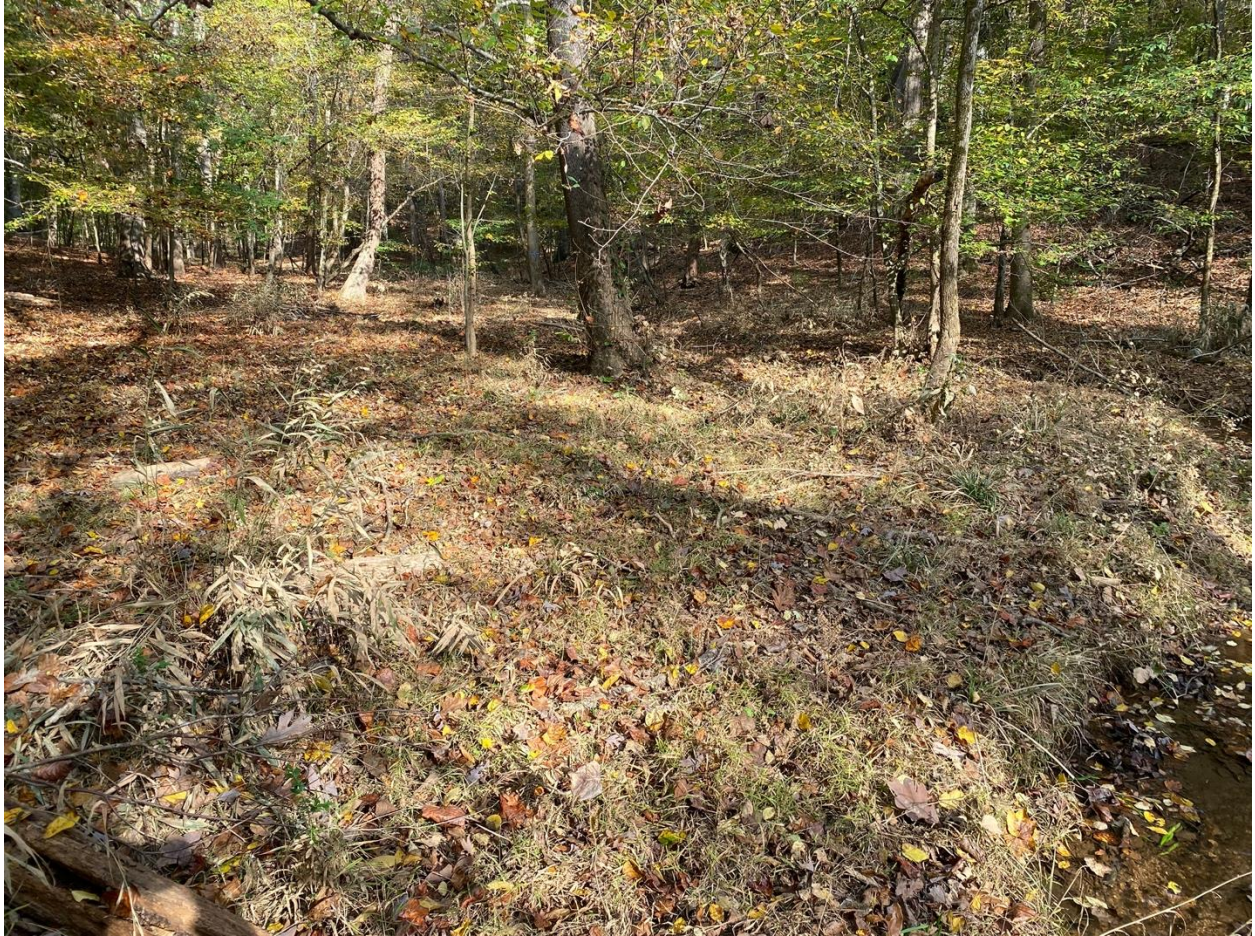
Figure 15. A photo showing a large area of *Microstegium* in the floodplain.

In places designated as large colonization areas (blue polygons on Figure 13), we recommend using more aggressive control methods. One recommendation is the use of flame weeding. This method is ideal in moist areas where the threat of the fire getting out of control is mitigated. Flame weeding is practiced during the seedling stage of a plant (Beitz Thomson and Frye). This will ensure the seedlings are controlled before seed production. It would be best to do this control during late winter as *Microstegium* begins to seed during early to mid-spring. A possible downside to flame weeding is the habitat and vegetation around the targeted species. The flame weeding has the potential to kill off some of the wanted vegetation surrounding the invasive species and therefore is recommended for heavily infested areas with not much native vegetation.

Mowing or weed-eating is another great technique for larger colonies of *Microstegium*. A large mowing operation in late summer has been found to be effective for reducing seed

production. The most effective method to control the *Microstegium* in a large colony would be chemical spraying. We recommend carrying this out on large, established patches of the plant to stop its spread. Glyphosate, the active ingredient in Roundup, has been shown to perform well on invasive species. High soil absorption of the chemical limits leaching and spread of the chemical to other plants, although it should be applied carefully. With an average half-life of around two months, the ecosystem can return to normal. There are glyphosate mixtures that are non-toxic, but certain mixtures can cause damage to wildlife (Tu et al. Pg 7e1). Sethoxydim is another chemical control agent that works well to fight grasses. This chemical has an average half-life in soil of a few days. Known to be low-toxicity and does not affect broadleaf or woody plants. One downside is the chemicals low soil absorption which can lead to spread on the property (Tu et al. pg 7J.1). Our client has expressed a preference for non-chemical strategies, but it is important to note as an effective method should the *Microstegium* infestation progress to the point that other methods become impractical.

Lastly, revegetation of native plants after control techniques is highly recommended and known to be an effective method in blocking the return of invasive plants and returning the habitat to its natural state. As mentioned previously, Wood Oats and Nimblewill can be two effective plants for this purpose as well as assisting in erosion control. Although this can be a costly endeavor, grants and state programs may help mitigate those costs and we recommend contacting the local UGA Cooperative Extension Office (706-613-3640, or online at: <https://extension.uga.edu/county-offices/clarke/agriculture-and-natural-resources.html>) for technical expertise and information on incentives and cost-share programs.
